# Building Stabilization Plan Review

## St. Paul's School Garden City, NY

Issued for Review: December 17, 2010  
L&M File No.: 10-0929-00

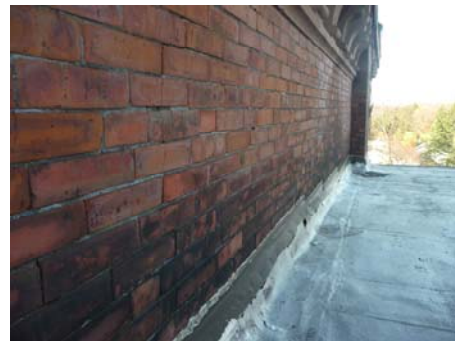
**Figure 1**

Numerous locations examined during the walk through were noted to have blistered plies and open seams (figure 1). The roof system and its components generally have exceeded their useful life.

Replacement of roofs and their related accessories as recommended in the building stabilization plan is complete “rip and replace”. At the low slope (or flat) roofs, a complete removal of the existing and replacement with a new SBS modified system is recommended. Typically, these roofs carry a warranty up to twenty-five (25) years and typically exceed the warranty period with regular maintenance.

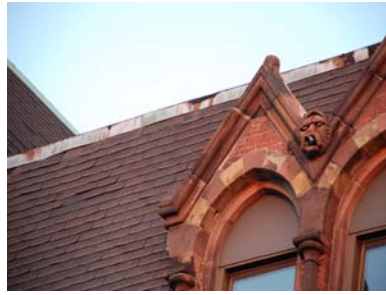
**Figure 2**

The existing roof system on the mansard roof areas are constructed of asphalt shingle (figure 2) – this system is not the original system; which was most certainly slate shingle as it still remains on the clock tower (figure 3).

All the asphalt shingle roofs have exceeded their useful life. Most location observed have missing and worn shingles. These mansard roof areas drain to gutters located at the perimeter of the roof. The existing gutters are red copper (with patina) and generally appear to be in good working order and condition (figure 4). There are areas, however, where some replacement will be required.

At the mansard roof, a complete removal of the existing and replacement with new thirty (30) year asphalt shingles is recommended. LM was informed by the Committee that the State Historic Preservation Office (SHPO) has indicated that asphalt shingles may be entertained if an “asphalt shingle with enough texture to stand up to the rest of the building” could be found.

The recommended material by SBG to be used at the mansard roof is considered inappropriate by this office for use with preservation standards given the complete replacement and the knowledge that the original material was slate. If the work at the mansards were simply repairs and not a complete replacement, then asphalt shingle would be acceptable (currently in-place). Research indicates that faux slate (with a warranty period of 50 years) may be an acceptable and appropriate substitute material at the mansard

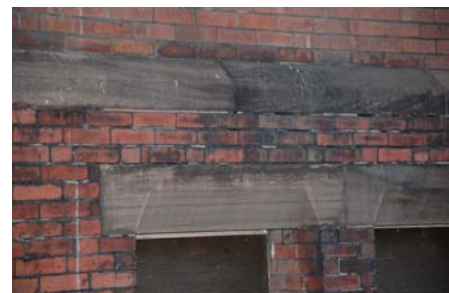
**Figure 5**

As is typical to most structures of similar vintage and construction, the most prominent façade deficiency noted was weathered and deteriorated mortar joints (figure 5).

Mortars (both bedding and pointing) are designed to be softer and/or more permeable than the surrounding masonry – this prevents damage to the individual units. Typical stresses within the wall

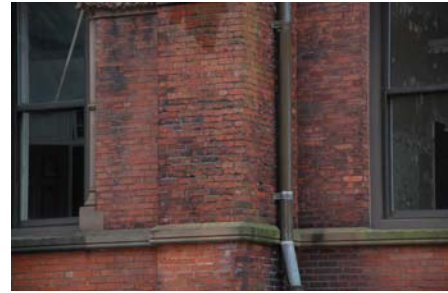
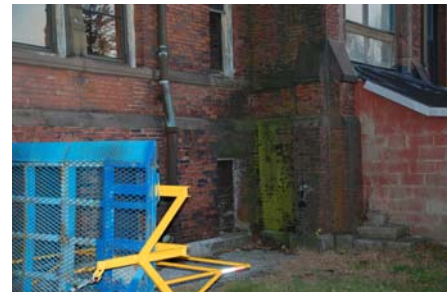
resulting from expansion, contraction, moisture migration or settlement must be accommodated; in a masonry wall, the stresses are relieved by the mortar – not the masonry units. Mortar repairs are far less expensive than masonry unit repairs. In some cases, mortar deterioration has progressed too far and replacement of masonry is the only option (figure 6 and 7).

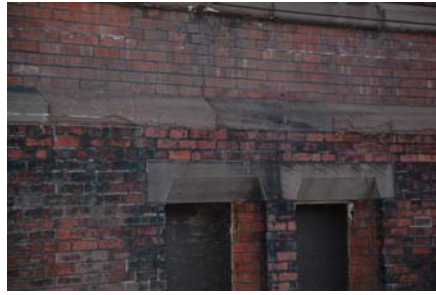
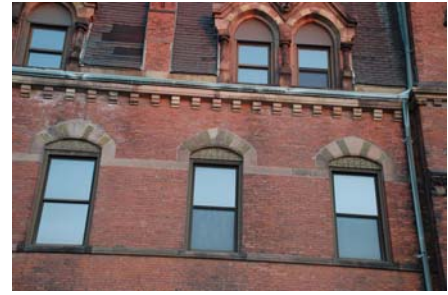
In addition, localized areas of cracked and displaced masonry were also noted (figures 8 and 9). The cause of this damage is typically exposure and age. The extent of damaged brick masonry is limited and vast areas of brick replacement will not be required.

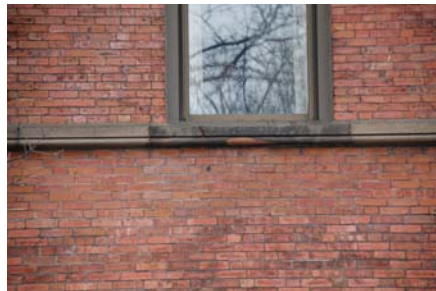
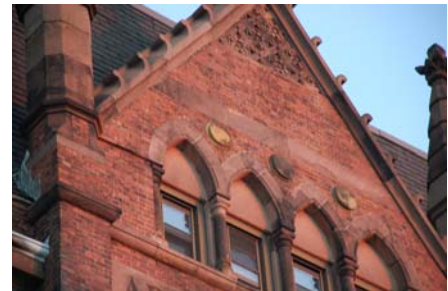
By in large the most prominent envelope feature is the stone adornments. The lintels, window arches, water tables, sills and bands are only a few of the stone elements ornamenting the facades. The stone exhibits typical signs of weathering and deterioration, exfoliation, contour scaling, and disaggregation (figures 10 and 11). Although these conditions were noted, most are repairable through composite patching with limited areas of dutchman replacements also expected. The limited visual assessment performed by this office did not indicate areas requiring full unit replacement.

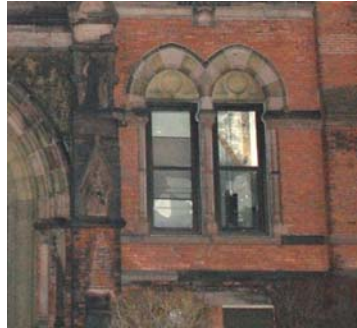
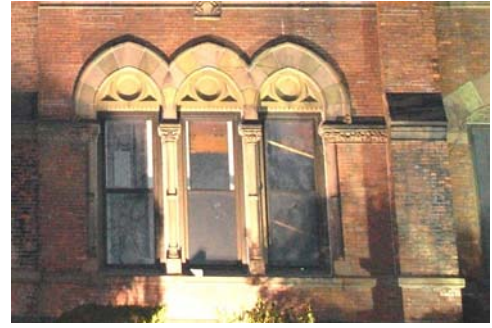
The windows are aluminum, double hung, insulated replacement windows. The exact age and time of installation is not known by this office, but based upon our experience, the age is estimated to be in excess of twenty-five (25) years old. A limited number of windows were operated by LM and their condition documented. Generally the integrity of most of the replacements is intact, however, difficulty of operation was noted and racked/broken sashes (figure 12 and 13).
